REPORT NO. 3552

NORFOLK AND WESTERN RAILWAY COMPANY

IN RE ACCIDENT

AT EAST BLUEFIELD YARD, W. VA., ON

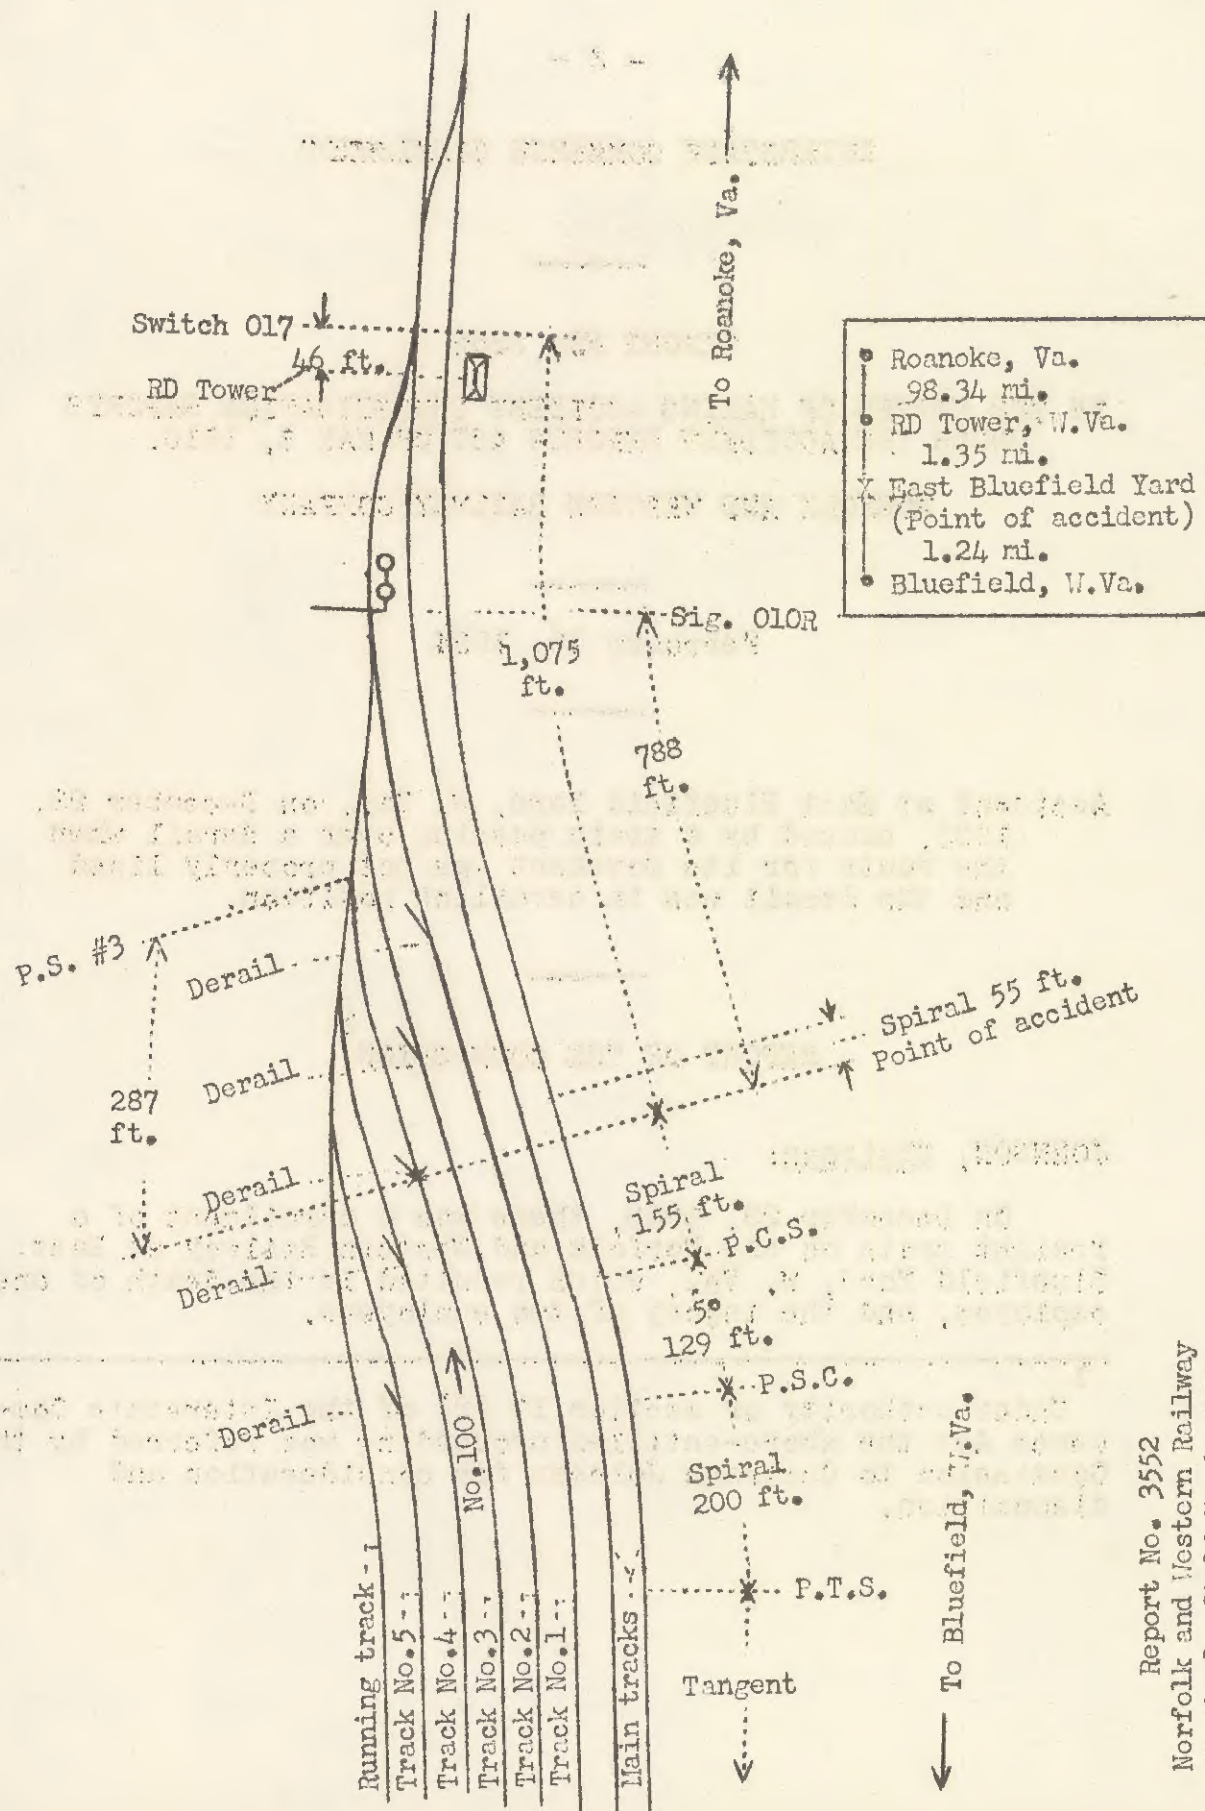
Report No. 3552
Norfolk and Western Railway
East Bluefield Yard, W.Va.
December 28, 1953

No. 100, an east-bound fourth-class freight train, which originated at East Bluefield Yard, consisted of engine 2049, 29 cars, and a caboose, 2,607 tons. It departed from a point on track No. 3 approximately 4,000 feet west of the derail near the east end of the track, and while moving at a speed of about 5 miles per hour the engine and tender, the first car, and the front truck of the second car were derailed at the derail, which was in derailing position.

The train stopped with the front end of the engine 185 feet east of the derail. The derailed equipment remained approximately in line with the track. The engine leaned to the north at an angle of about 45 degrees. Three washout

After the accident occurred, the derail in track No. 3 was found to be in derailing position. The switch at the east end of the track was in position for movement on the running track. The switch lamp at the derail was displaying a red aspect, and the switch lamp at the switch was displaying a green aspect. These are the proper aspects when the switch and derail are in these positions. Inspection and tests of the signal apparatus disclosed no defective condition.

Although the results of this investigation are not conclusive as to whether the derail was moved as the train was approaching, the investigation disclosed that there was nothing to prevent the operator from moving the derail at any time that the track section in which the derail was located was unoccupied. Since the track section extends only 20 feet west of the derail, this condition constitutes a definite hazard. The carrier should provide means to prevent the movement of these derails while a train is closely approaching.
